NATIONAL BUREAU OF STANDARDS REPORT

INVESTIGATION OF THE DIRECTIONAL EFFECTS IN THE STRESS CORROSION OF ALUMINUM ALLOYS

Final Report

April 22, 1968

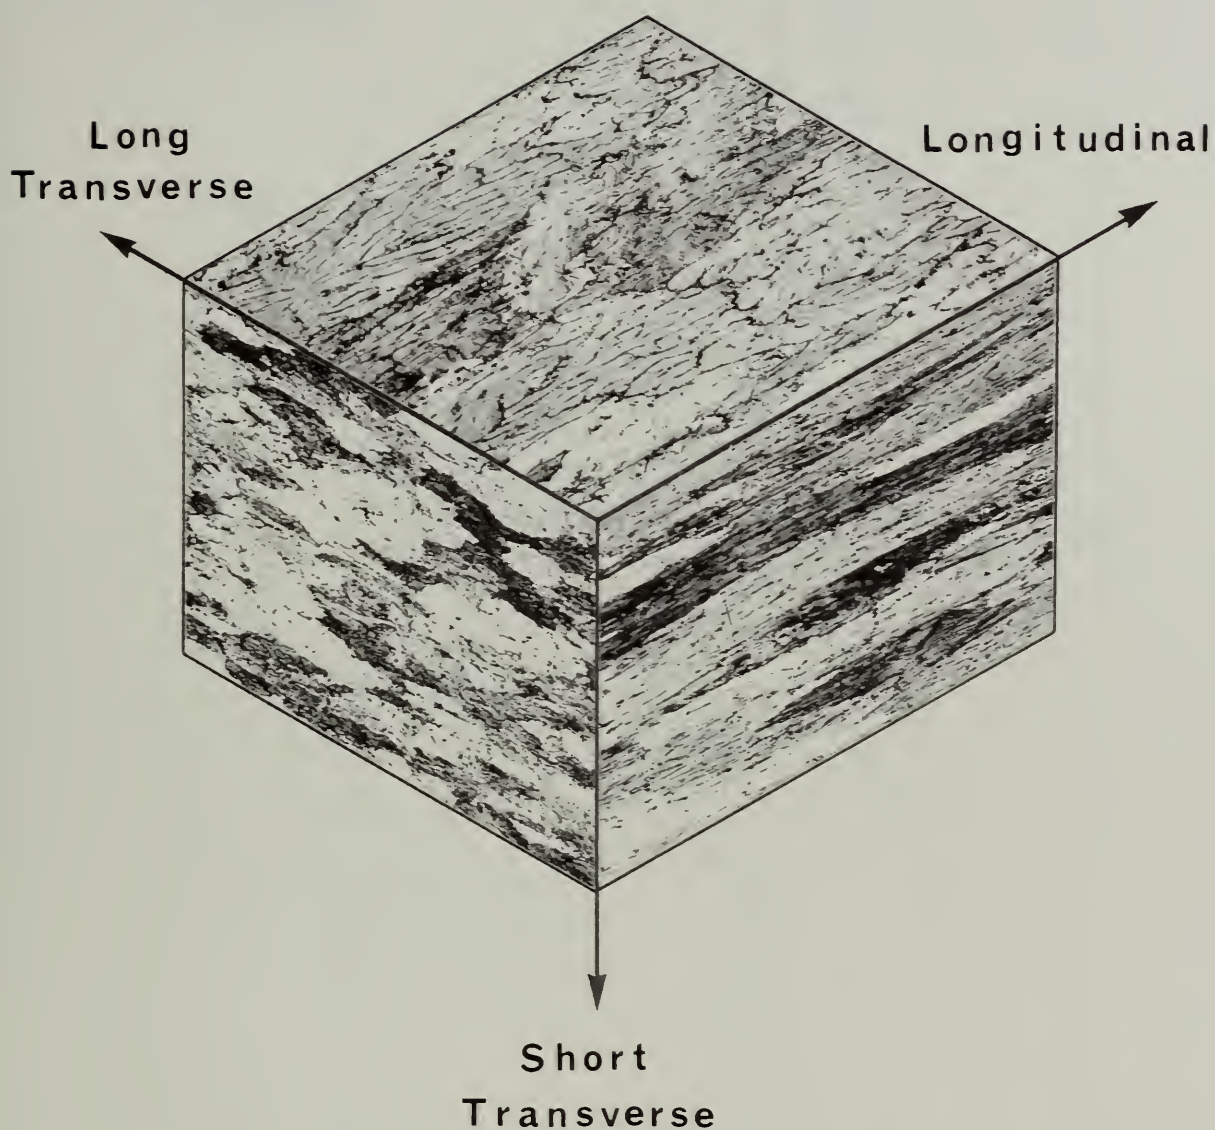
FIGURE 1

Composite photomicrograph of the grain structures in three orientations at the center of a 2.5-inch thick plate of 7075-T651 aluminum alloy. Etched in Keller's etch. X 50

During the fabrication of some wrought, high strength aluminum alloy products, the grains become very elongated and do not significantly recrystallize on further heat treatments (Figure 1). These products also retain a high degree of preferred orientation (texture). The reported instances of stress corrosion cracking failures⁽¹⁾ in aluminum alloys have resulted from residual or assembly tensile stresses acting in the short transverse direction relative to the grain structure (Figure 1). Longitudinal tensile stresses, on the other hand, have rarely caused stress corrosion problems. Hence, it is very important to understand in more detail this great dependence of stress corrosion cracking susceptibility on stress direction in the wrought, high strength aluminum alloys

The material was evaluated to confirm both the mechanical properties and the stress corrosion susceptibility of specimens of three orientations (Figure 1) with respect to the rolling direction. For all material evaluation tests, a specimen of dimensions shown in Figure 2 was machined such that the reduced section was from the center of the plate. After machining, the specimens were polished parallel to the axes with number 600 silicon carbide paper as a final preparation before testing.

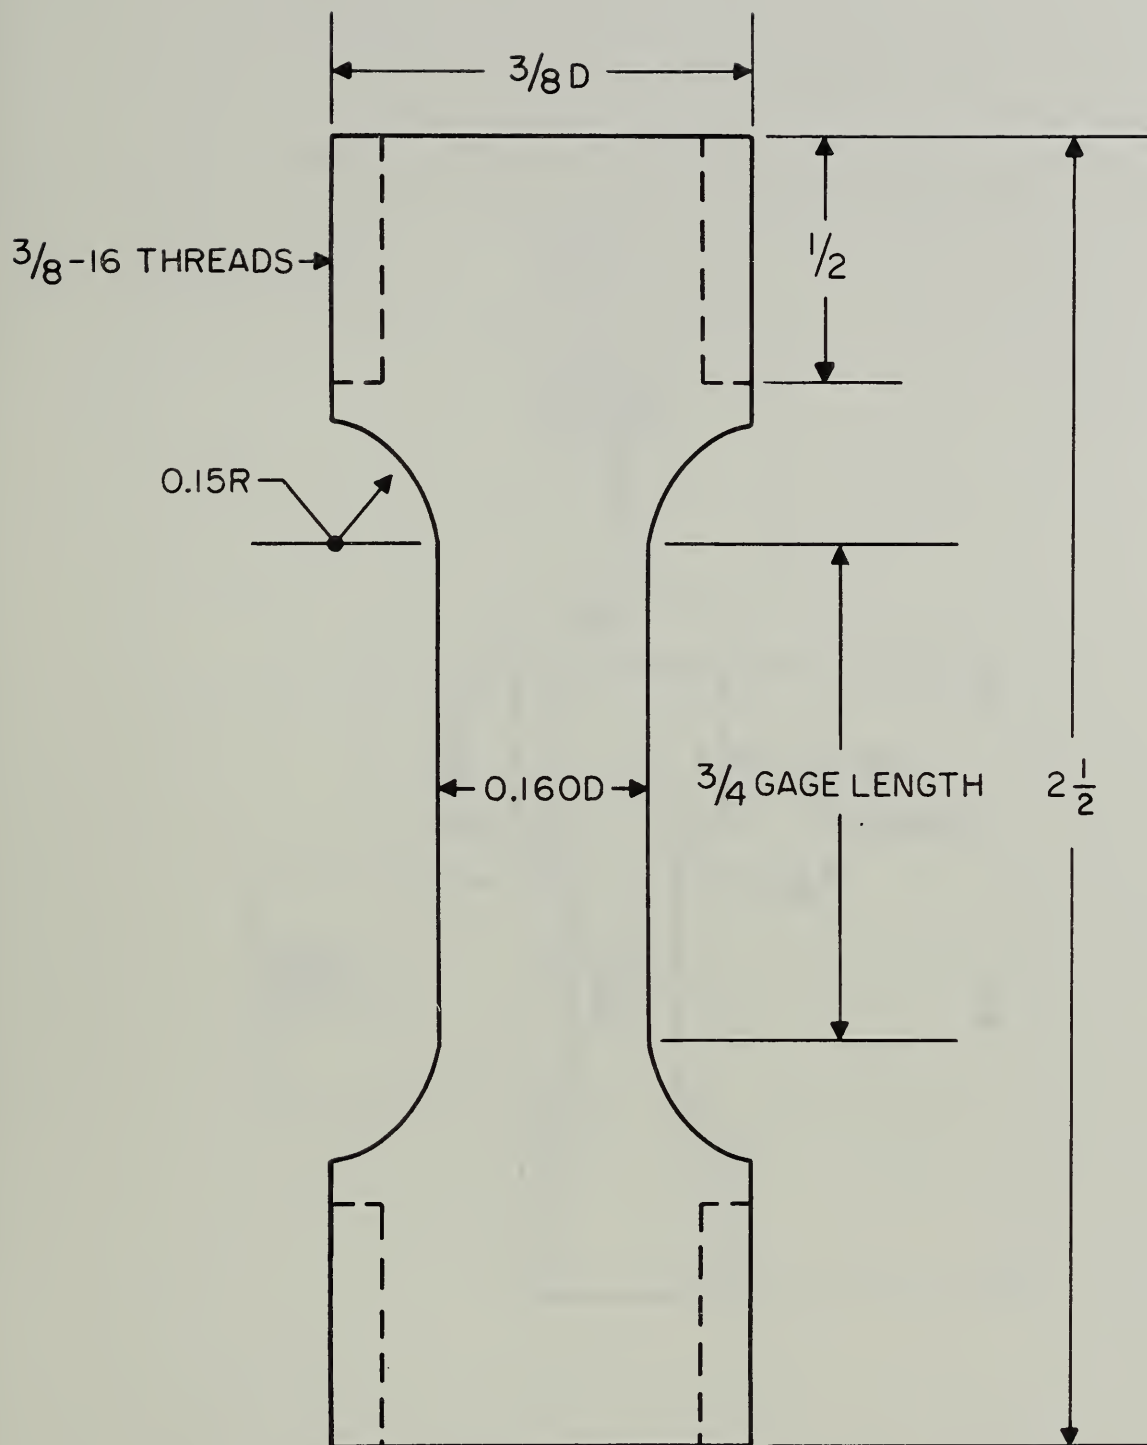
FIGURE 2

Specimen used for the material evaluation studies.

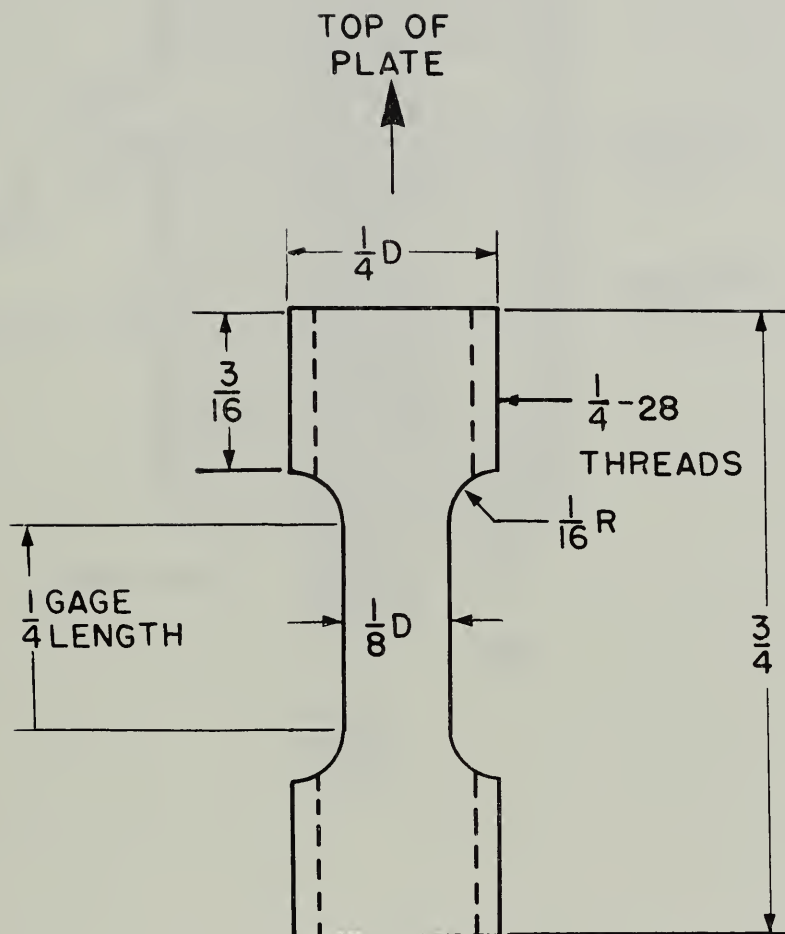
FIGURE 3

Miniature specimen used to determine the mechanical properties and susceptibility to stress corrosion cracking at various depths in the plate of material.

Figure 3 shows the specimen used to determine stress corrosion susceptibility as a function of specimen depth in the plate. The surface preparation was identical to that of the specimens described above.

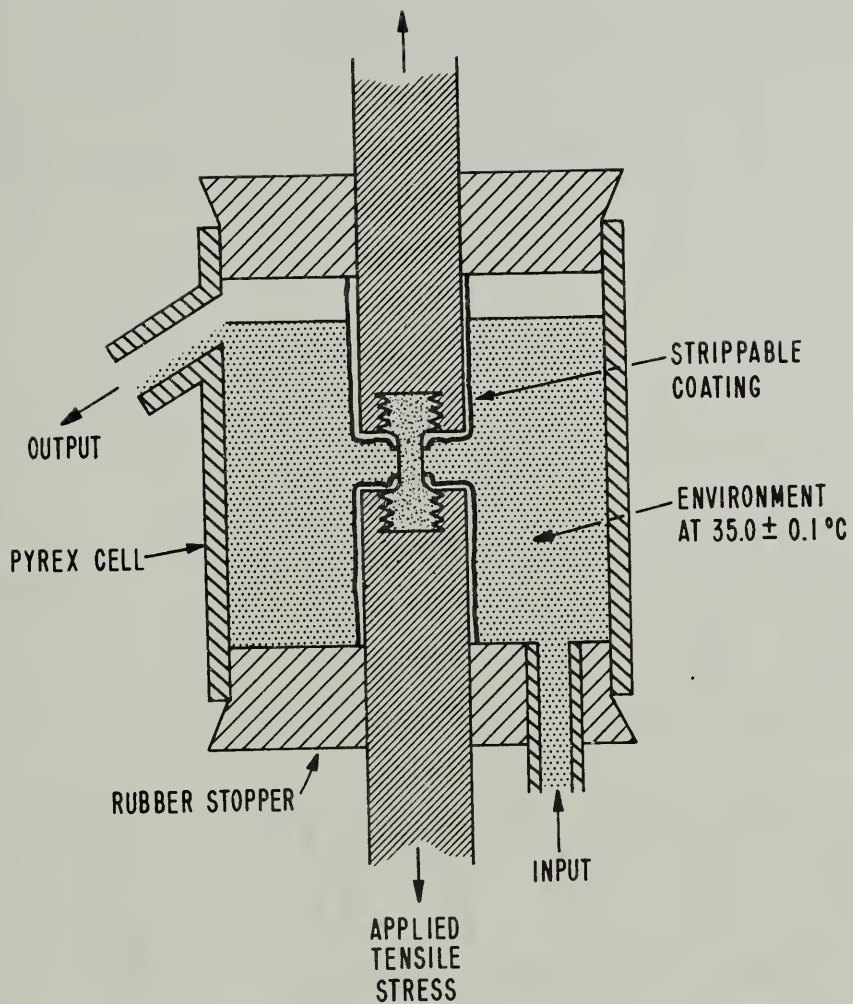
FIGURE 4
Stress corrosion susceptibility testing cell.

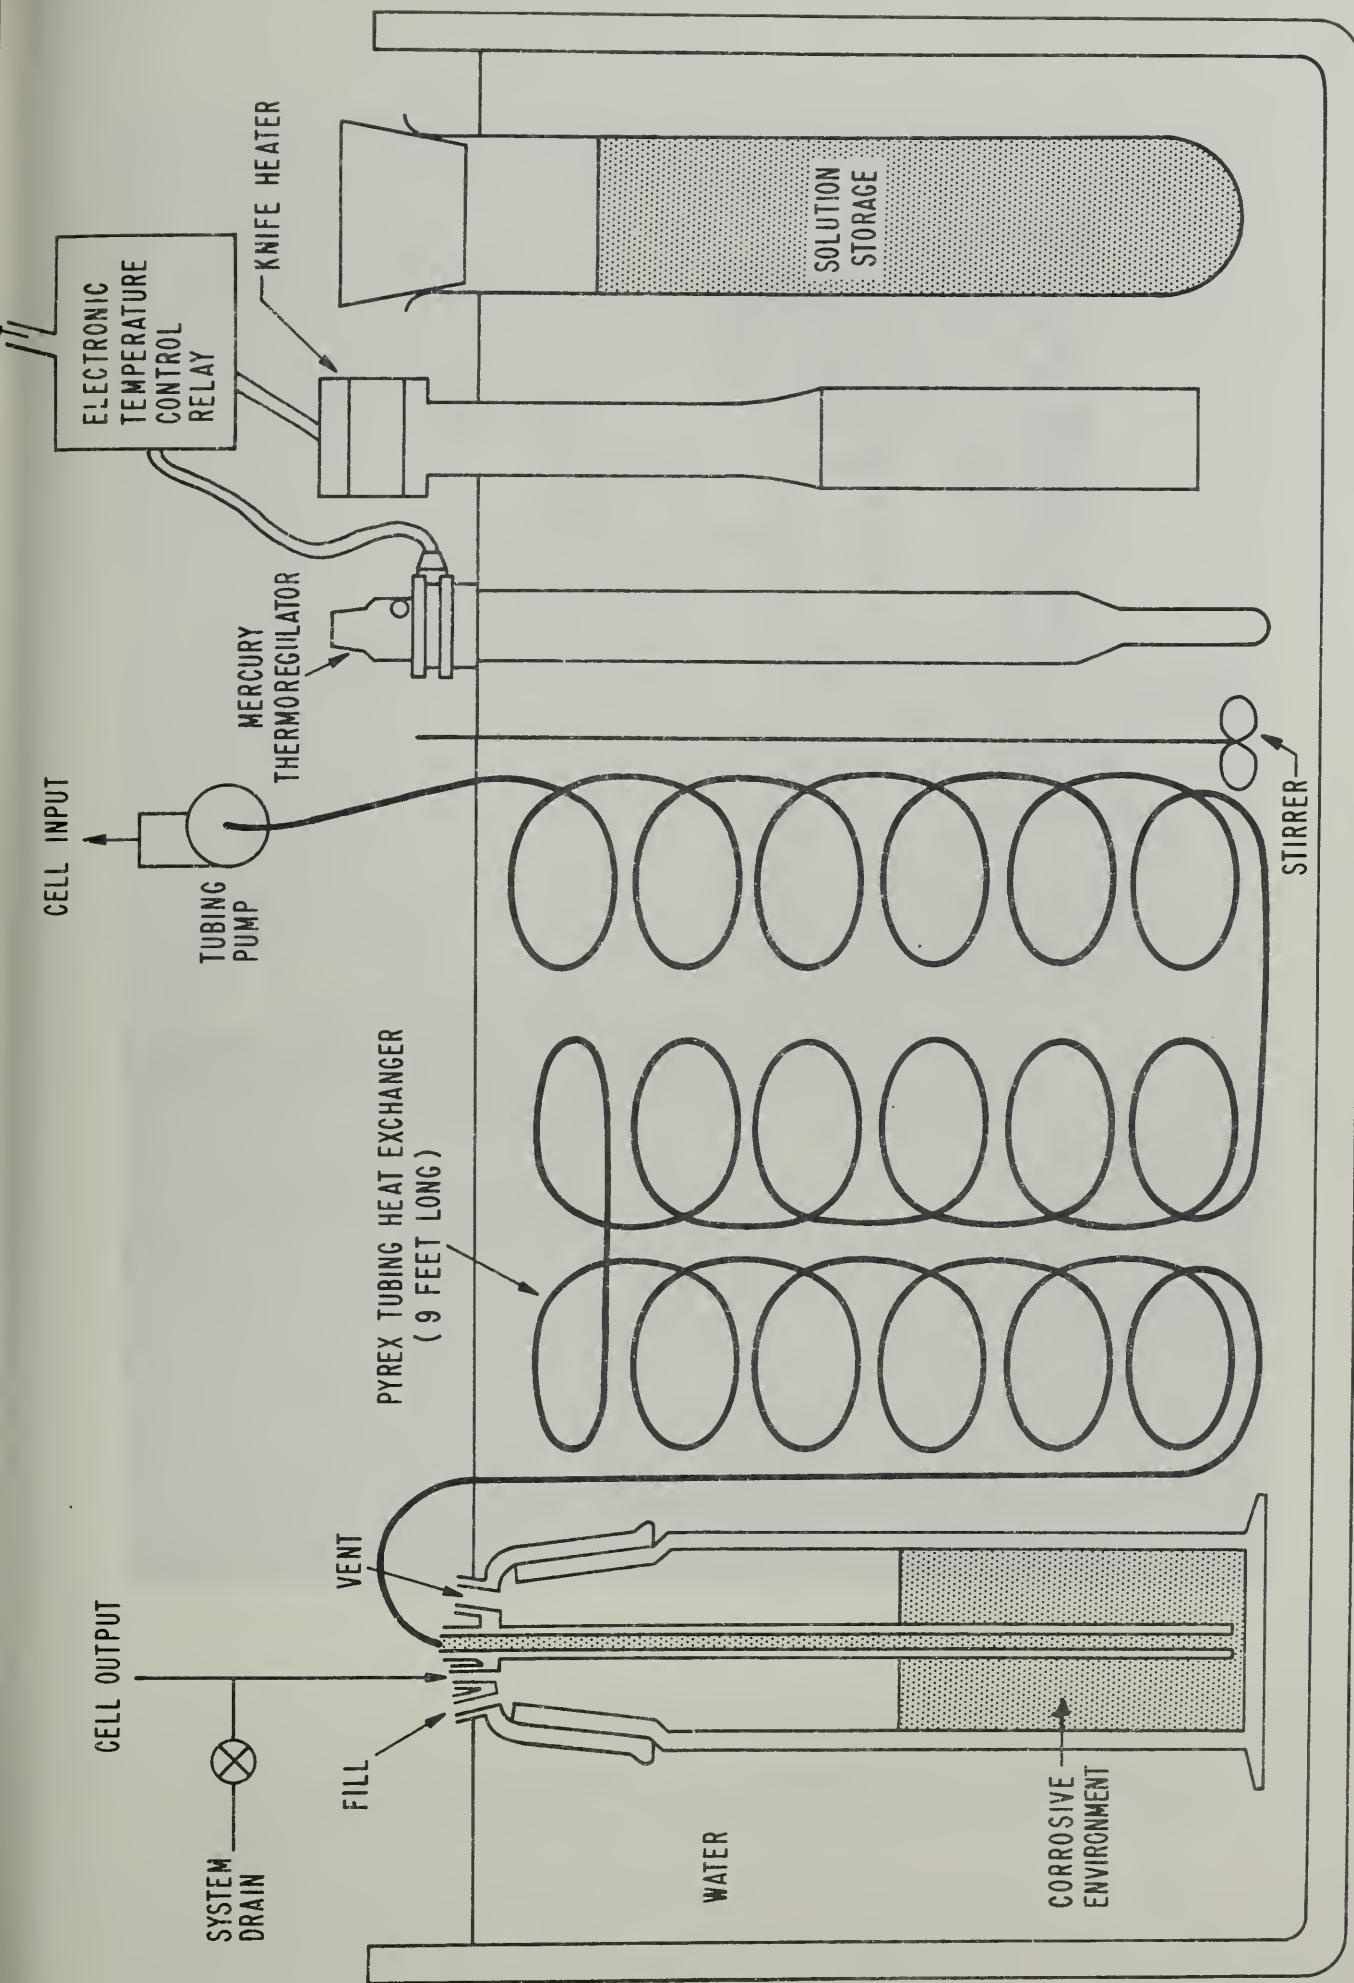
FIGURE 5

Recirculating constant temperature corrosive environment system.

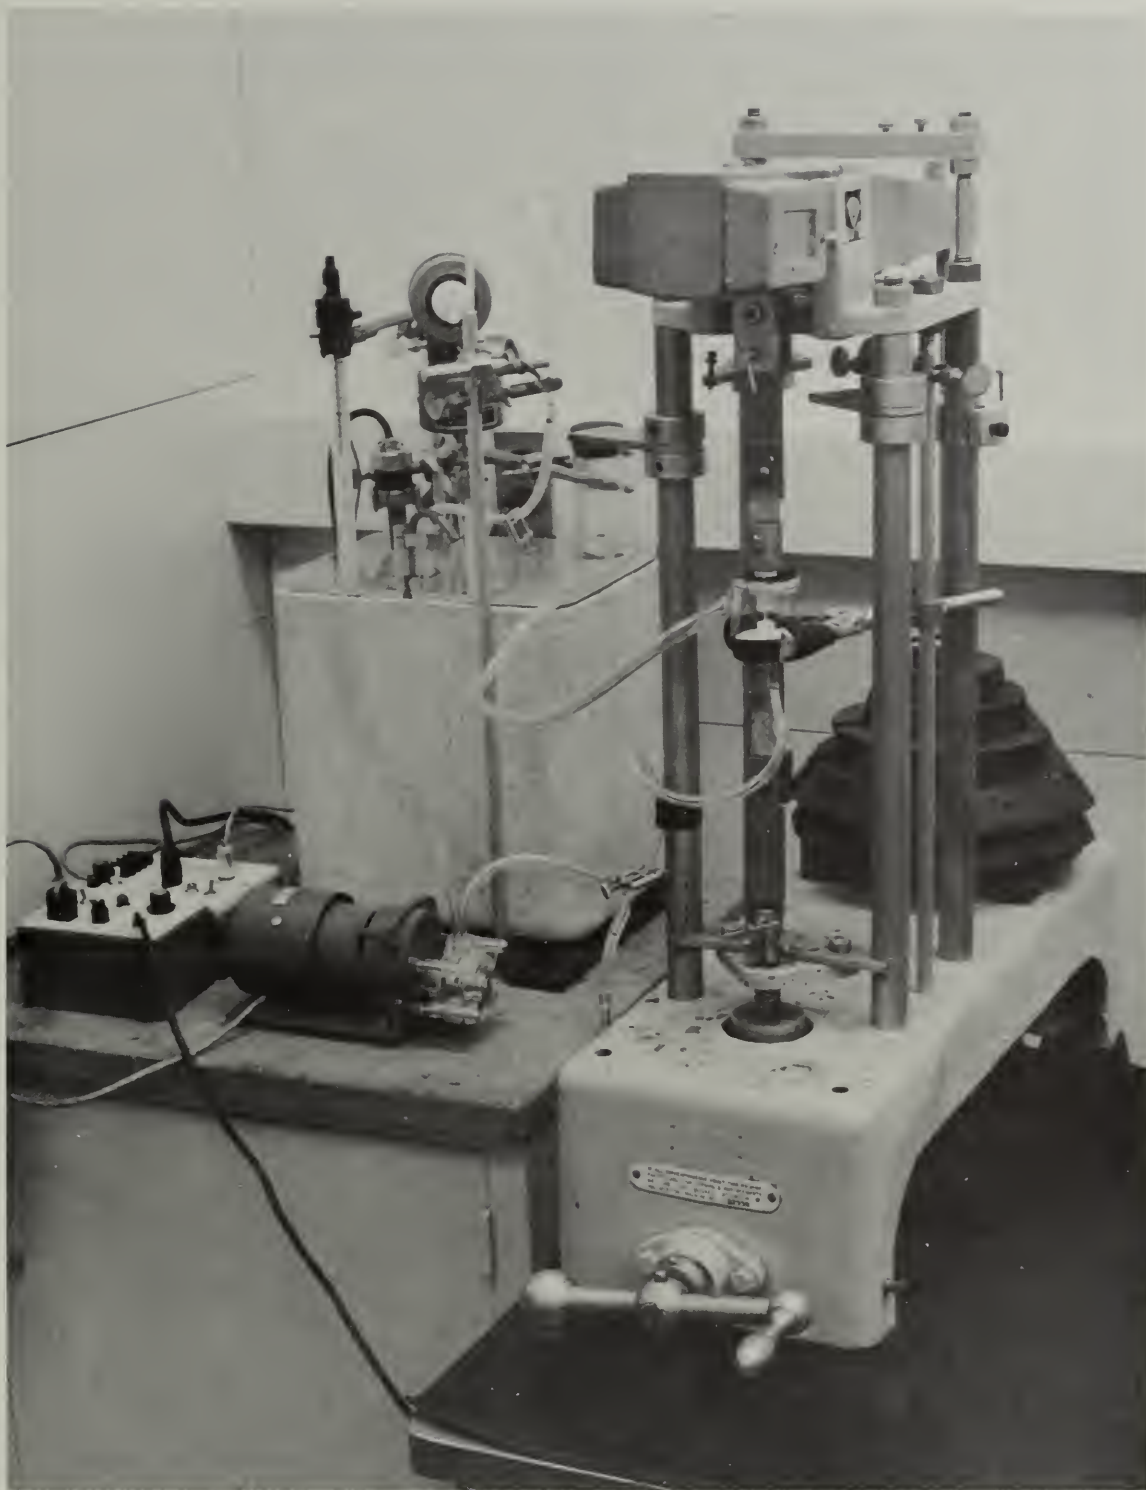
FIGURE 6

The complete stress corrosion susceptibility testing system. Items shown include those in Figures 4 and 5 and the loading frame.

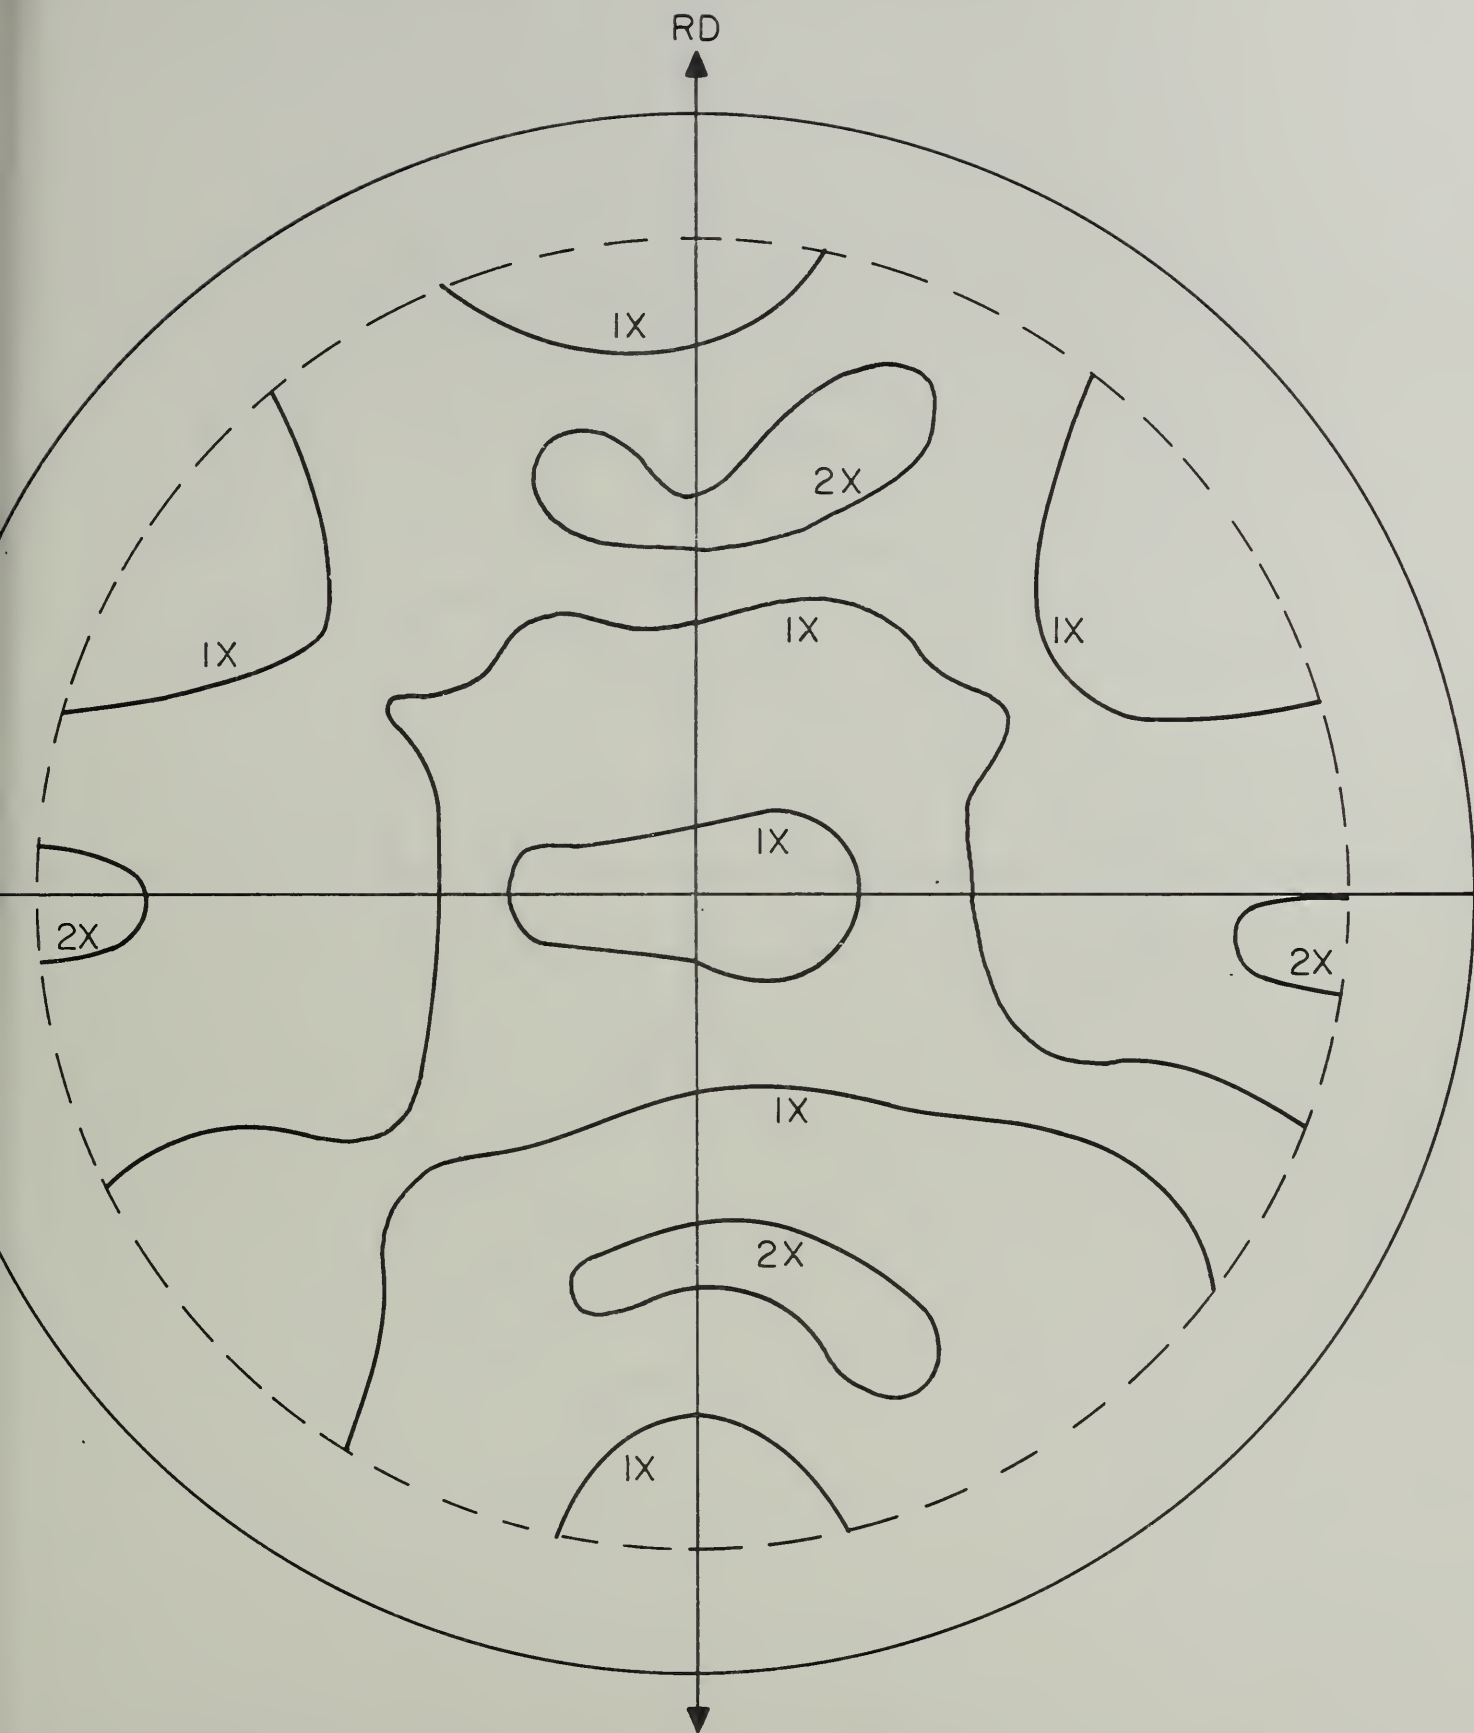
FIGURE 7

Absolute (111) pole figure for a plane of material at 0.26 inches below the surface of the plate. The constant intensity contours are shown as multiples of the intensity of the (111) reflection for a randomly oriented specimen.

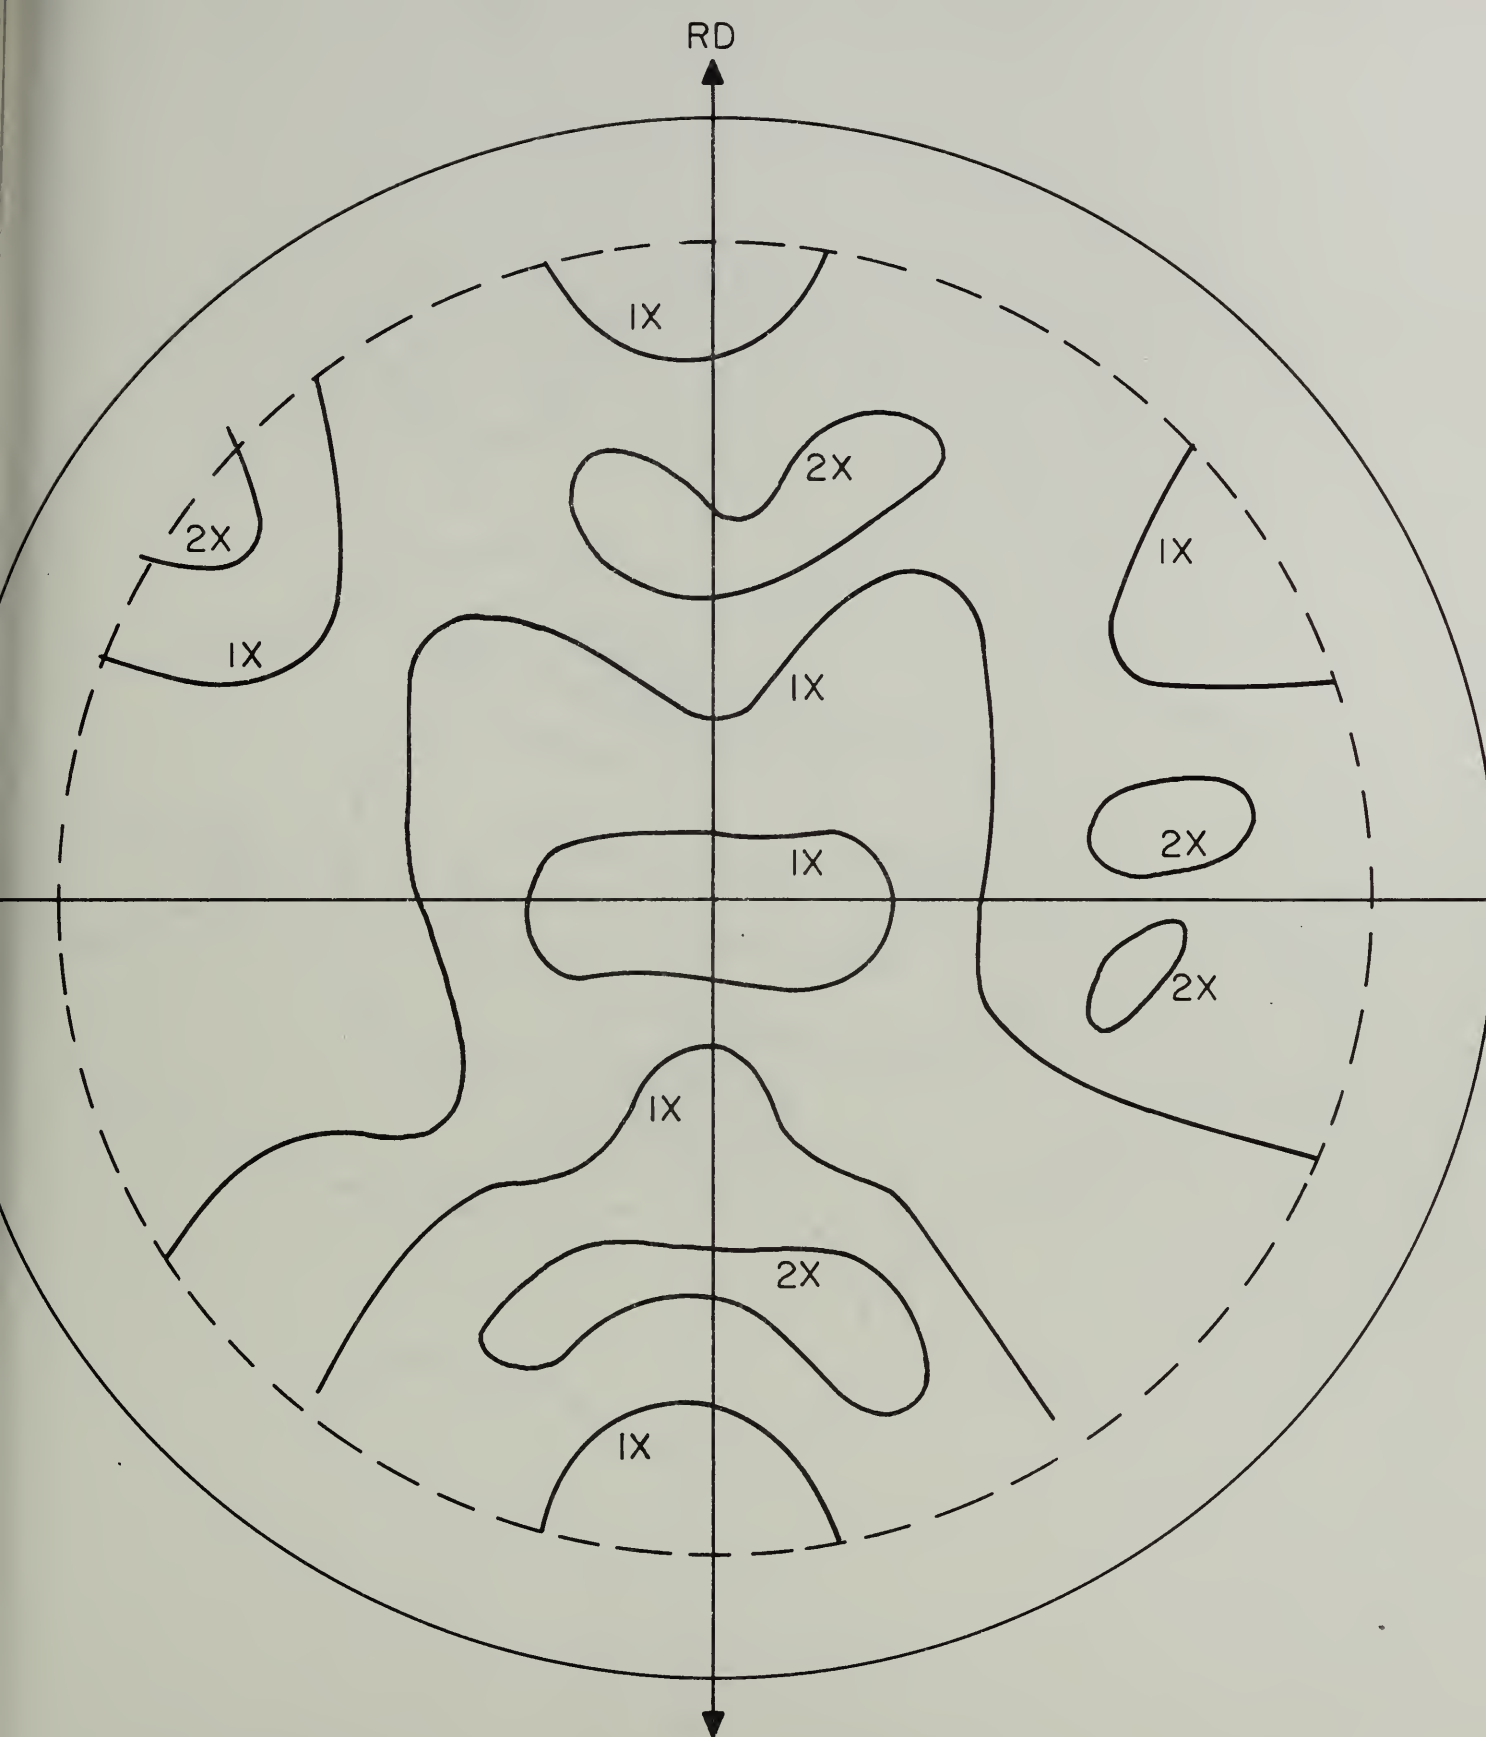
FIGURE 8

Absolute (111) pole figure for a plane of material at 0.57 inches below the surface of the plate. The constant intensity contours are shown as multiples of the intensity of the (111) reflection for a randomly oriented specimen.

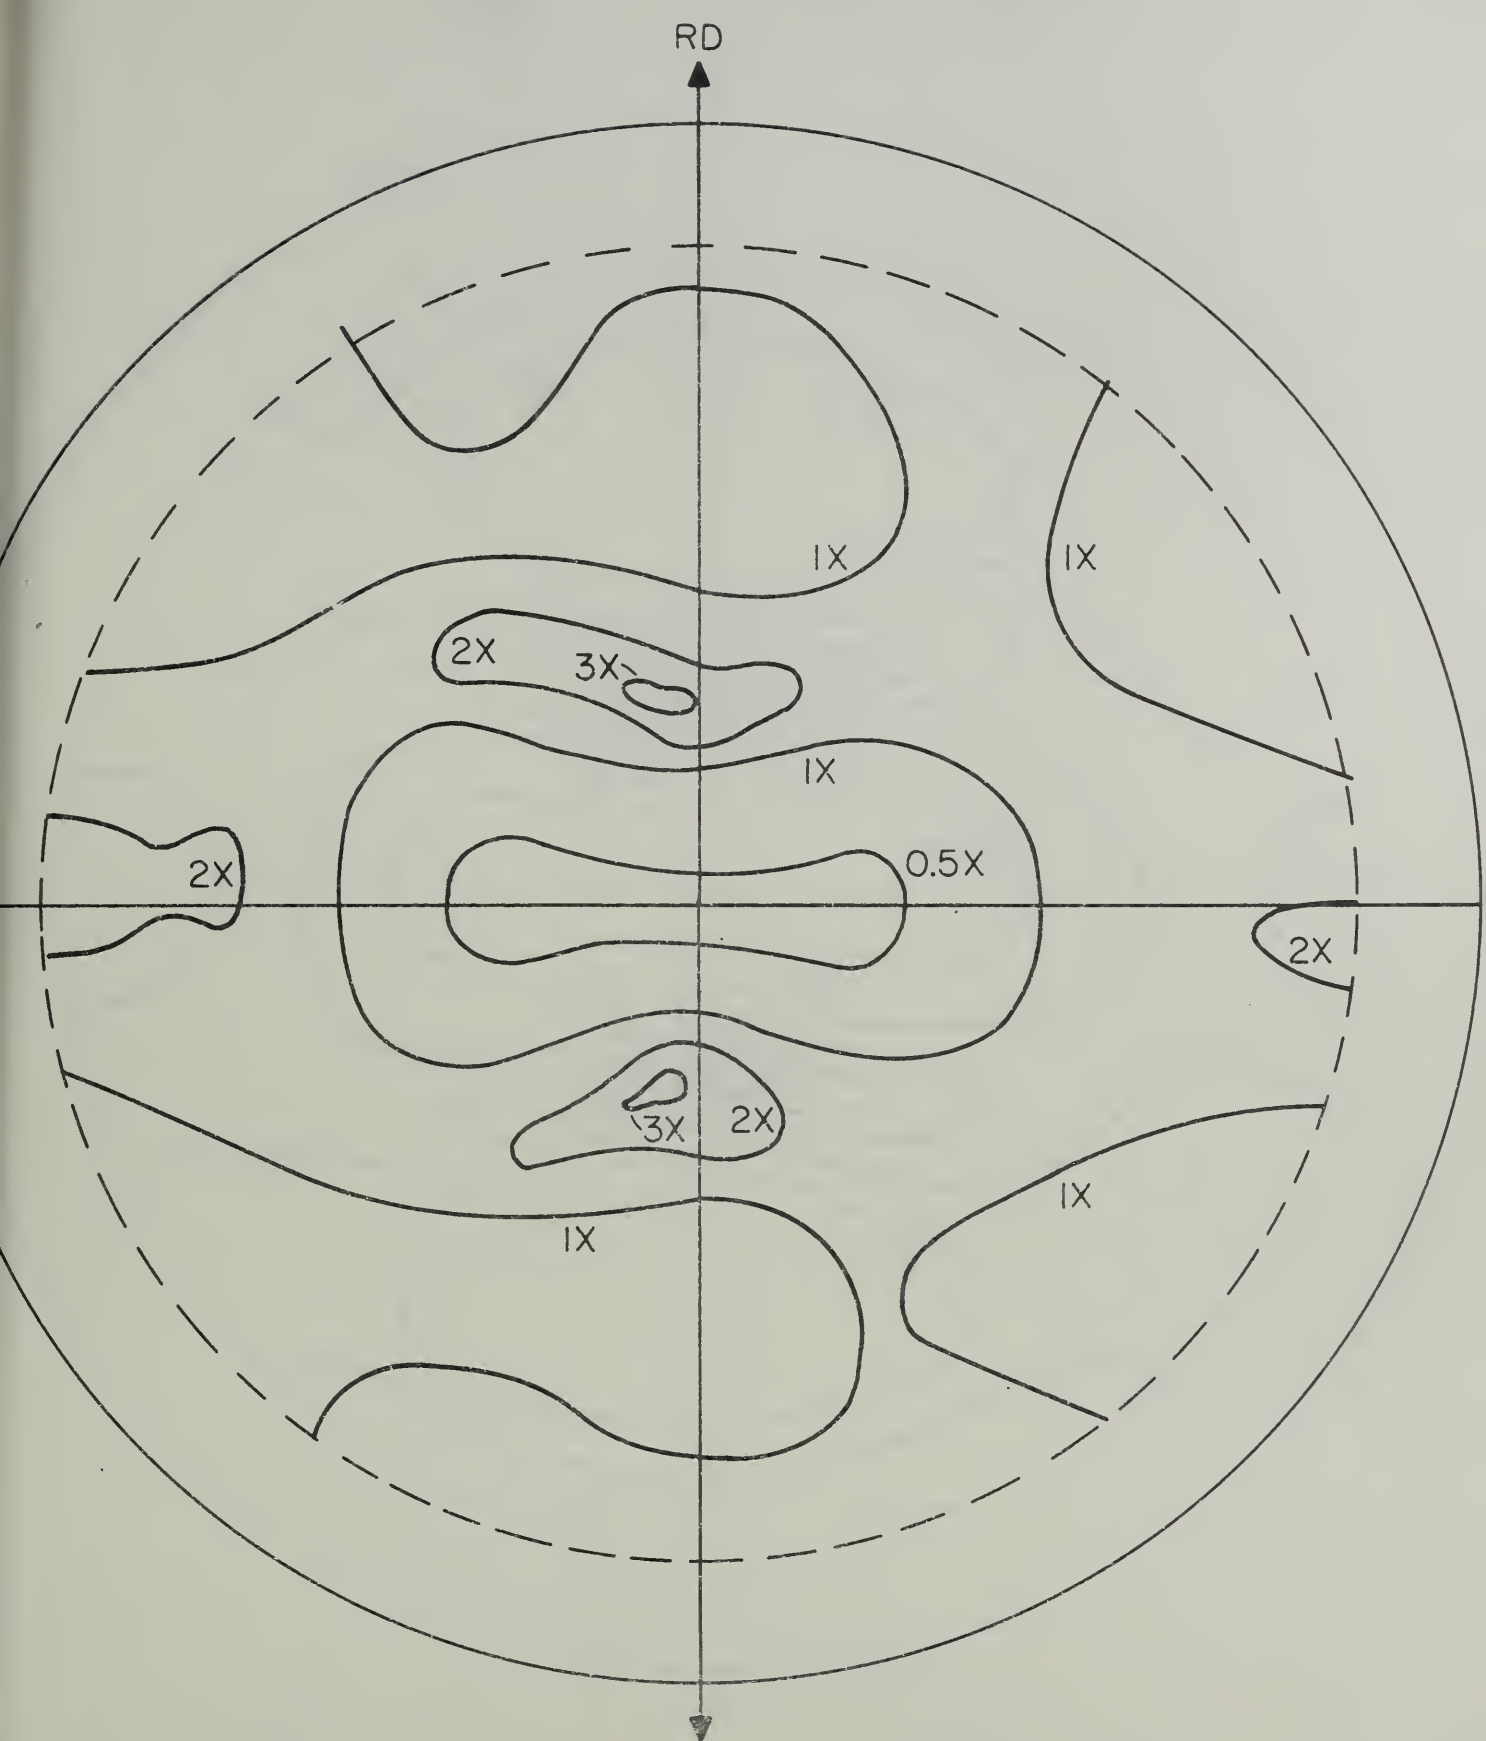
FIGURE 9

Absolute (111) pole figure for a plane of material at 0.73 inches below the surface of the plate. The constant intensity contours are shown as multiples of the intensity of the (111) reflection for a randomly oriented specimen.

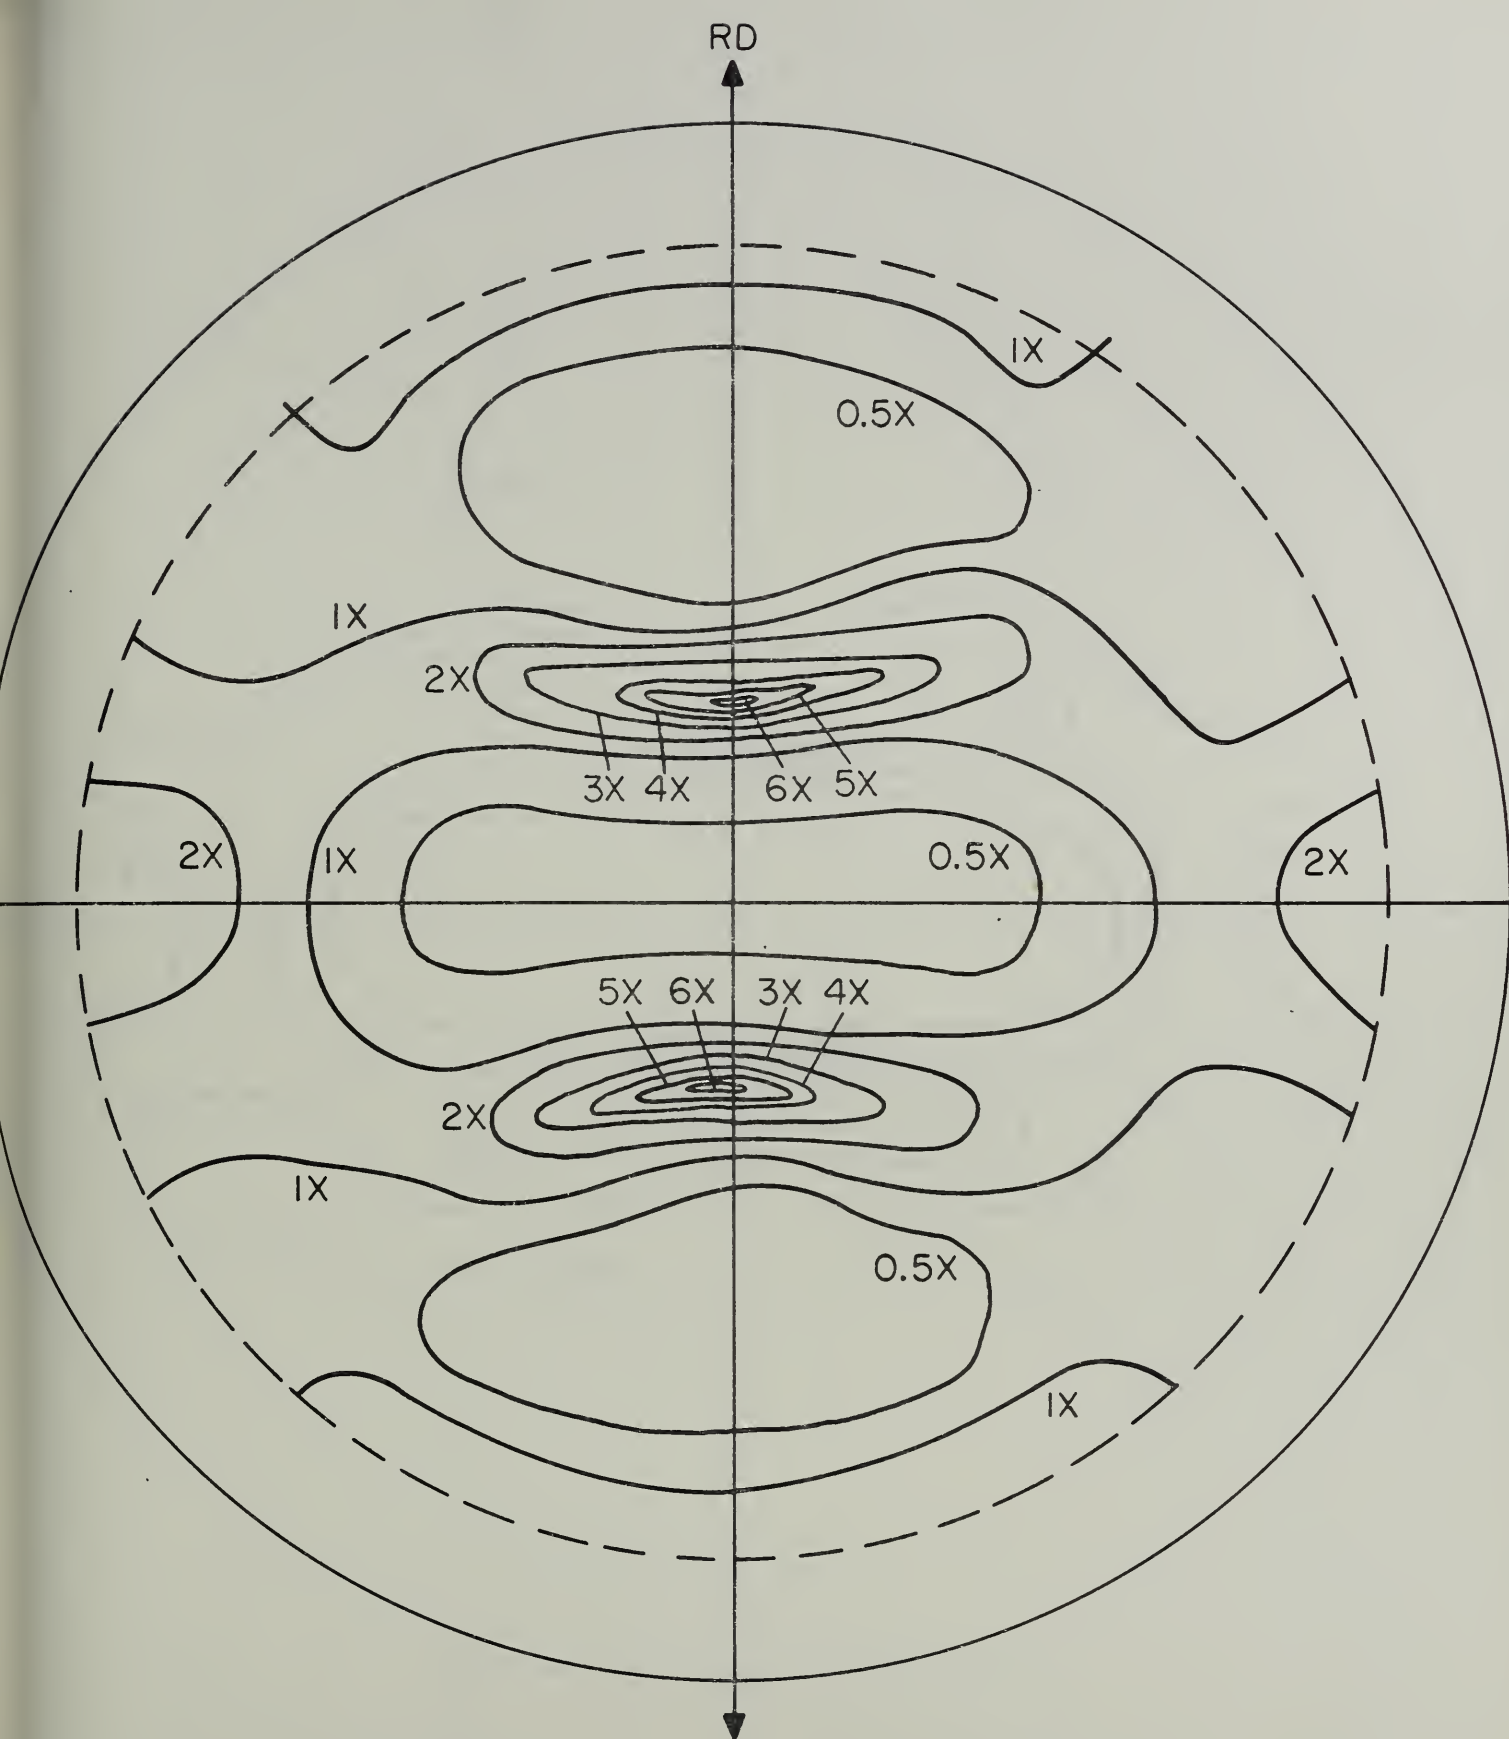
FIGURE 10

Absolute (111) pole figure for a plane of material at 0.89 inches below the surface of the plate. The constant intensity contours are shown as multiples of the intensity of the (111) reflection for a randomly oriented specimen.

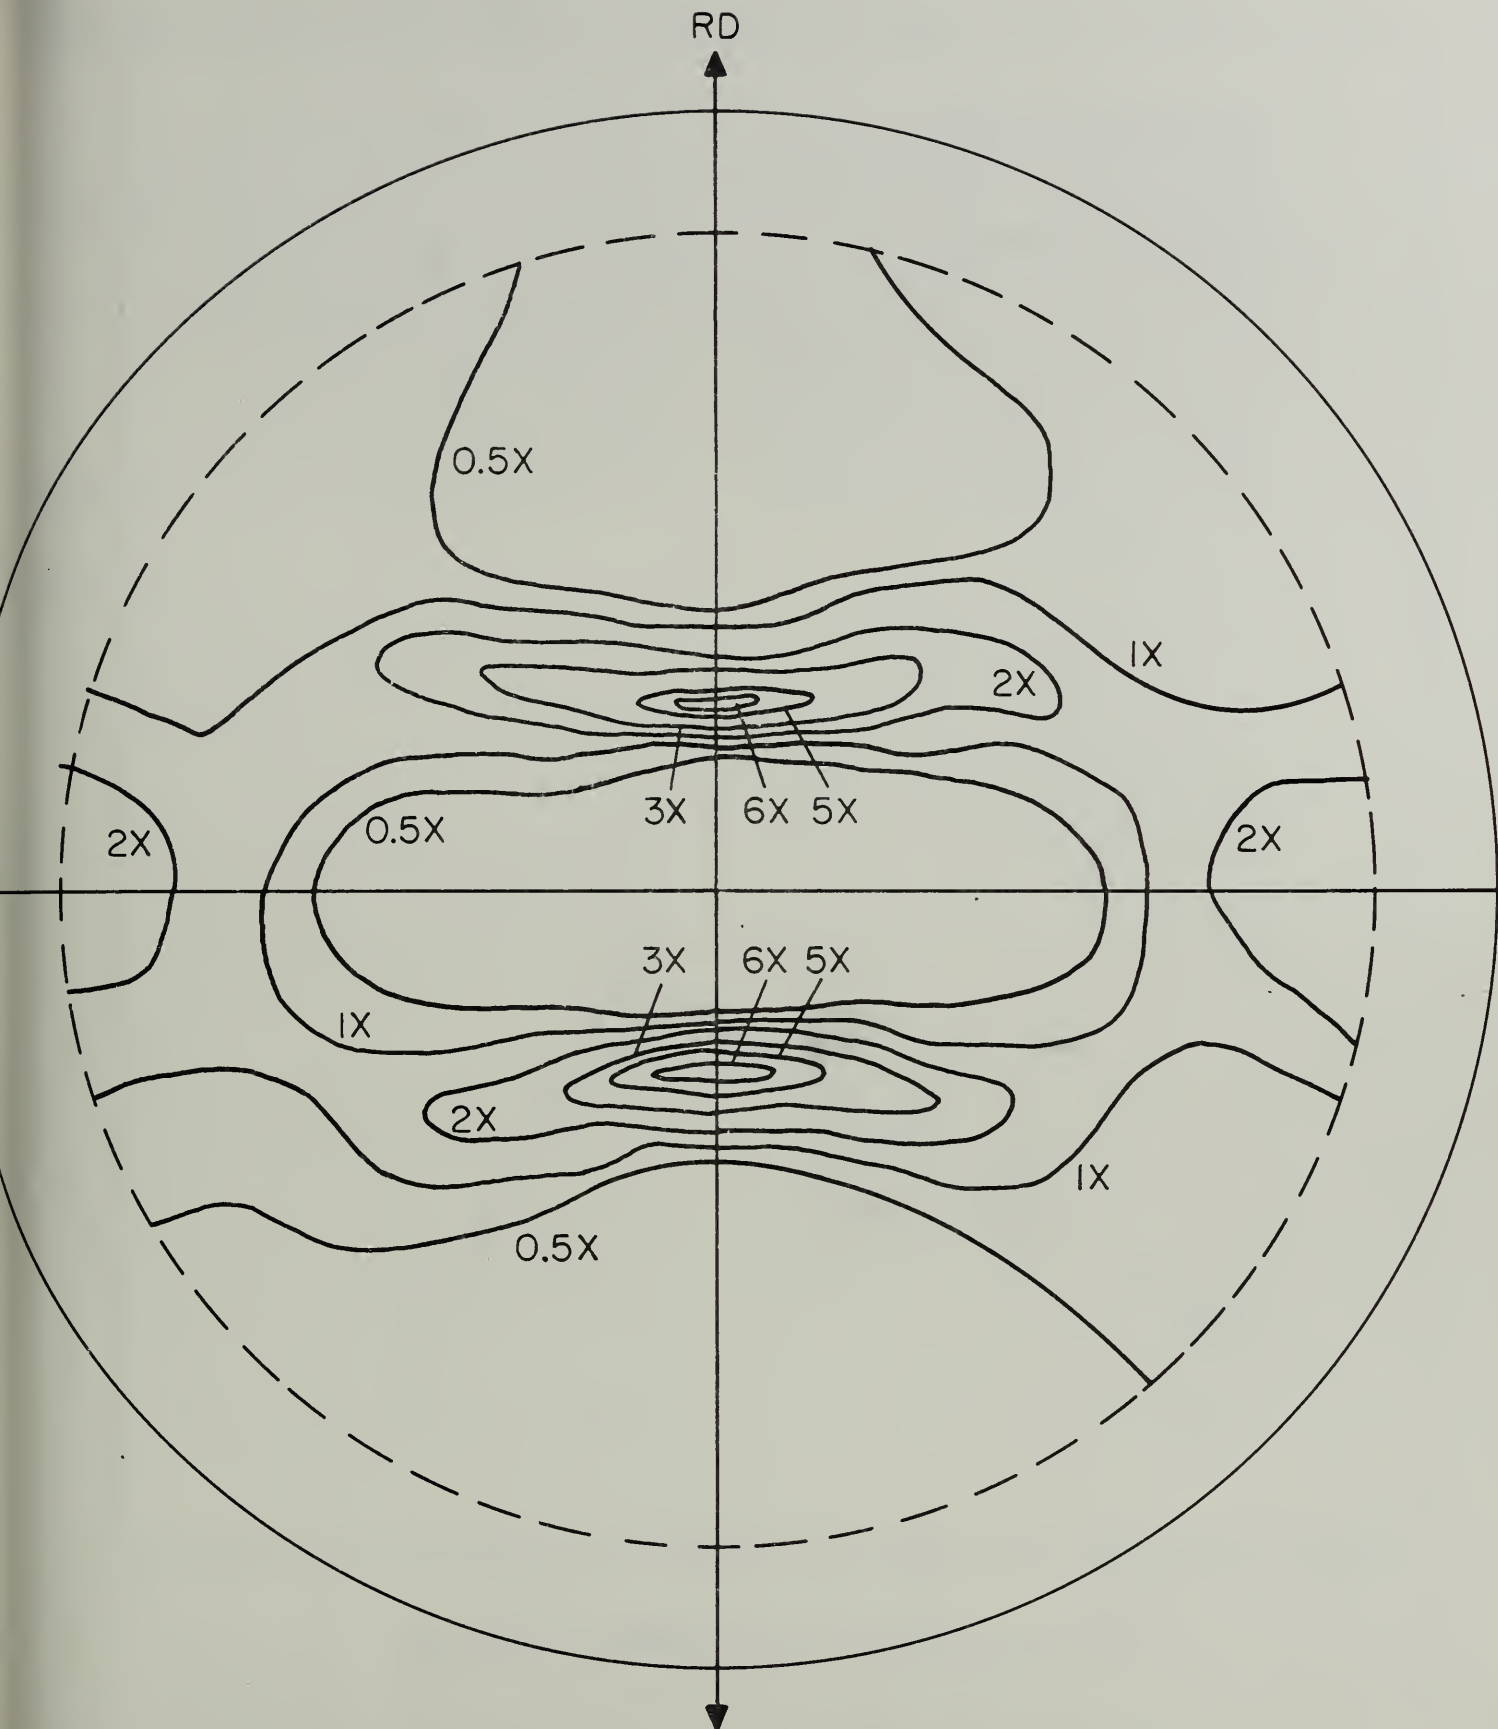
FIGURE 11

Absolute (111) pole figure for a plane of material at 1.20 inches below the surface of the plate. The constant intensity contours are shown as multiples of the intensity of the (111) reflection for a randomly oriented specimen.
